INDOOR AIR QUALITY ASSESSMENT

**Sumner Avenue Elementary School Annex
45 Sumner Avenue
Springfield, Massachusetts**

Prepared by:
Massachusetts Department of Public Health
Bureau of Environmental Health Assessment
December 2002

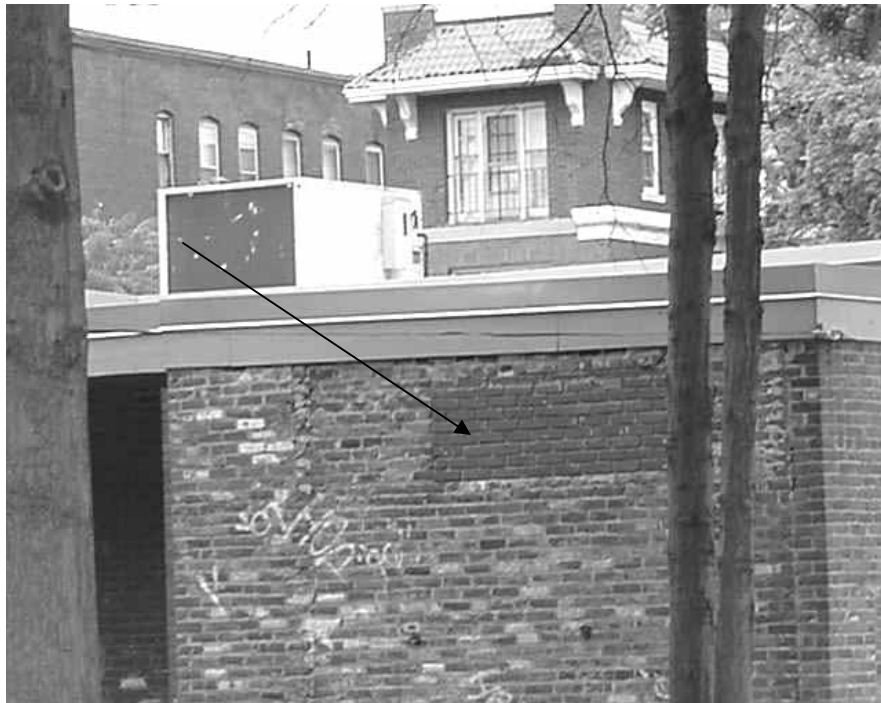
Picture 1

Fresh air in the annex is provided by a rooftop air handling unit (AHU) that was retrofitted to the building during the 1998 renovation project (see Picture 1). The AHU provides fresh air via ceiling mounted fresh air diffusers connected to ductwork. Air is returned to the AHU by a ceiling plenum that draws air through a series of grilles mounted in the ceiling. BEHA staff did not have a means of access to the roof to determine if the AHU has a means to exhaust air from the building or the condition of filters. Restrooms located in the rear of the building have ceiling-mounted exhaust fans activated by the light switch.

AHU in Roof of SAESA

To maximize air exchange, the BEHA recommends that both supply and exhaust ventilation operate continuously during periods of school occupancy. In order to have proper ventilation with a mechanical supply and exhaust system, the systems must be balanced to provide an adequate amount of fresh air to the interior of a room while removing stale air from the room. The date of the last servicing and balancing was not available at the time of the assessment. Since the system was added during the 1998 renovation, this system may have been balanced at that time. It is recommended that existing ventilation systems be re-balanced every five years to ensure adequate air systems function (SMACNA, 1994).

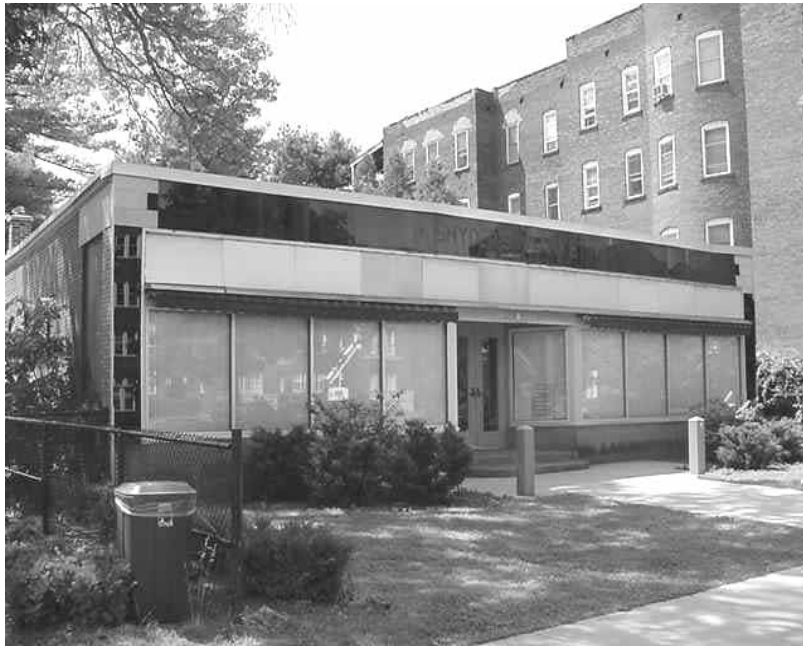
Picture 2

As noted previously, the basement had increased relative humidity levels compared to outdoors. A likely source of moisture appears to be water penetration through the foundation. The building has shrubbery and other plant/foliage in close proximity to its exterior walls (see Pictures 2 and 3). The growth of roots against the exterior walls can bring moisture in contact with wall brick and eventually lead to cracks and/or fissures in the foundation below ground level. Over time, this process can undermine the integrity of the building envelope and provide a means of water entry into the building through capillary action through foundation concrete and masonry (Lstiburek, J. & Brennan, T.; 2001).

Shrubbery in Close Proximity to Exterior Wall

- iii) Sealing the spaces around utility pipes that enter the occupied space through the floor.
- 6) Remove foliage at least five feet away from the foundation.

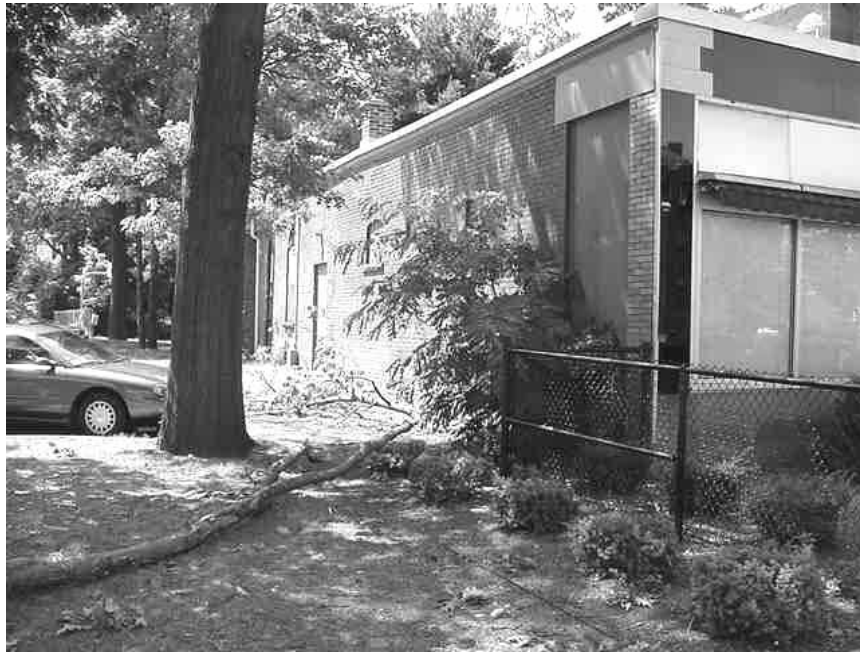
Picture 3

Plants Growing along Exterior Wall

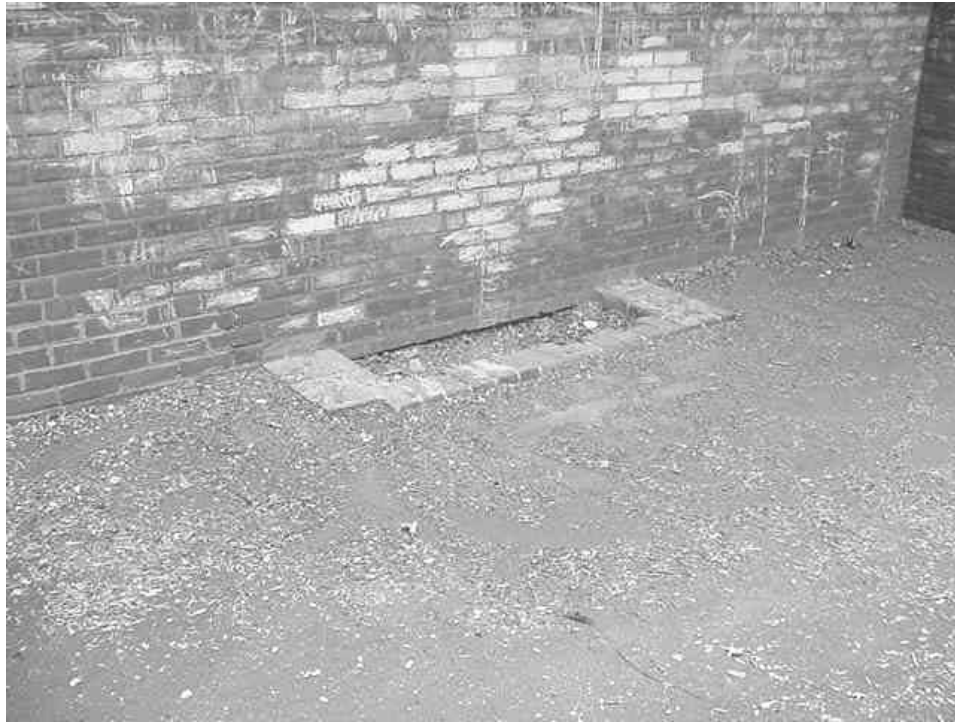
Picture 4

Another source that may allow water to penetrate through the foundation is what appears to be a former basement window pit located on the south exterior wall and the rear of the building (see Picture 4). Rainwater striking the south exterior wall will run off onto the ground at the base of the building and into this structure. This former window appears to be

sealed and was buried beneath soil. The configuration of this pit allows for water to accumulate within its brickwork as indicated by the erosion of soil beneath the exterior wall brick above the pit. Preventing water from coming into contact with the foundation in this area would help reduce potential water penetration into the basement through the foundation.

Filled in Pit at Rear of Building

- 7) Improve the grading of the ground away from the foundation at a rate of 6 inches per every 10 feet (Lstiburek, J. & Brennan, T.; 2001).
- 8) Install a water impermeable layer on ground surface (clay cap) to prevent water saturation of ground near foundation (Lstiburek, J. & Brennan, T.; 2001).

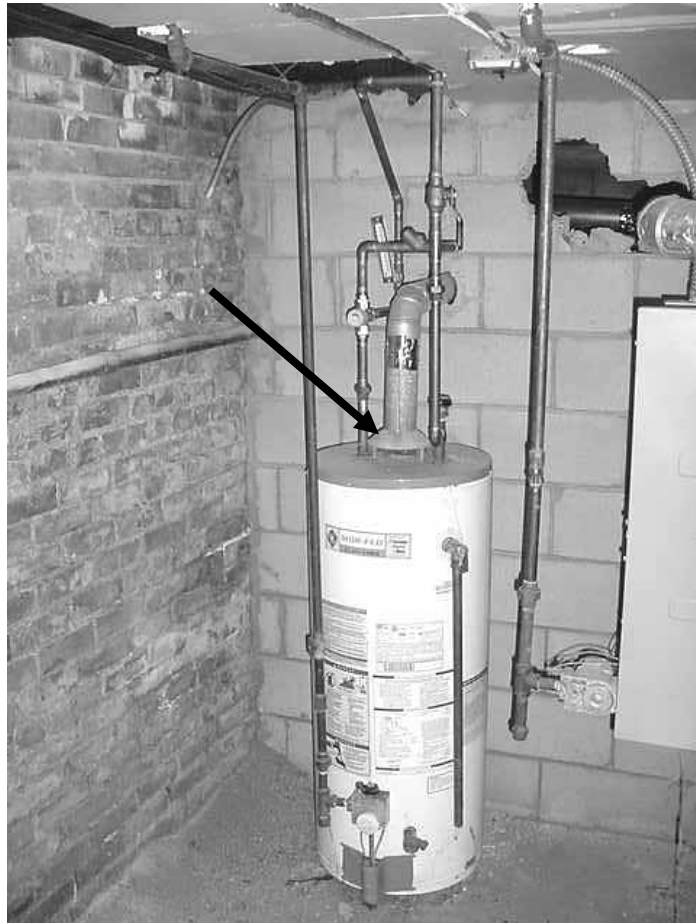
Picture 5

A gas fired heater (see Picture 5) and water heater (see Picture 6) located in the basement. Due to the configuration of the water heater and its exhaust vent, carbon monoxide (CO) measurements were taken in the basement prior to and after activation of the hot water heater. No detectable levels of CO were measured in the basement or classrooms at anytime during this assessment. In addition, no detectable levels of CO were measured during follow-up testing conducted on November 8, 2002. Of note was a rapid elevation of carbon dioxide levels once the water heater was activated for several minutes in the area above the exhaust vent ducting during the July air monitoring. During the November visit carbon dioxide measurements in the basement were 700 ppm above classrooms levels with no occupants. The basement air measurements indicate that a carbon dioxide production source exists in the basement that is independent of occupancy.

Please note the position of the space heater relative to the water heater. The exhaust vent for the water heater is not continuous (see Picture 5). Due to this configuration, products of combustion produced by the water heater can be drawn away from the vent system and directed into the basement when the space heater fan is operating.

Water Heater in Basement, Note Exhaust Vent Duct

- 2) Seal the water heater and space heater ducts to prevent CO penetration into occupied space. Do not operate bathroom exhaust vents until the duct is sealed.

- 4) Adequate combustion air needs to be provided for the water heater and space heater. A ground level fresh air intake may be necessary. Consult with the local fire prevention officer/building code officials to determine an appropriate method to provide combustion air for the water heater. If not feasible, consider replacing current gas water heater and space heaters with electric models.

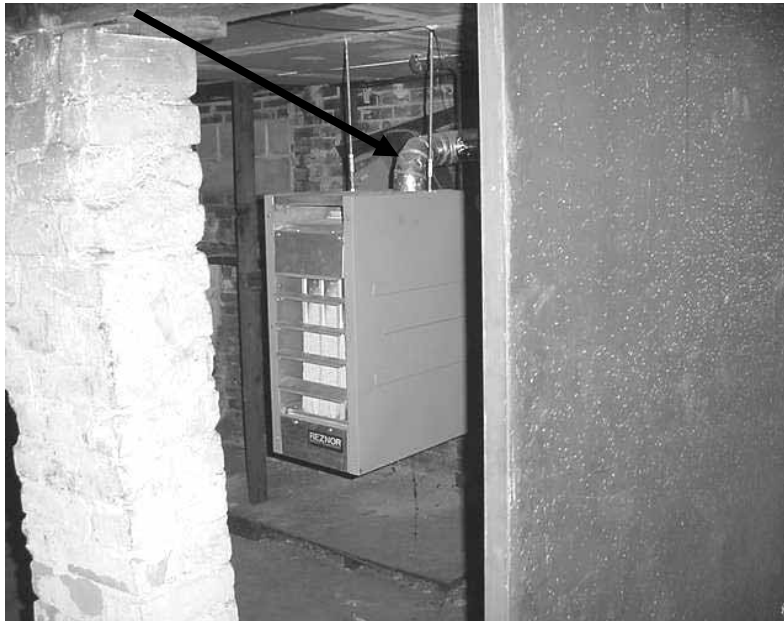
Picture 6

Space Heater in Basement, Note Exhaust Vent Duct

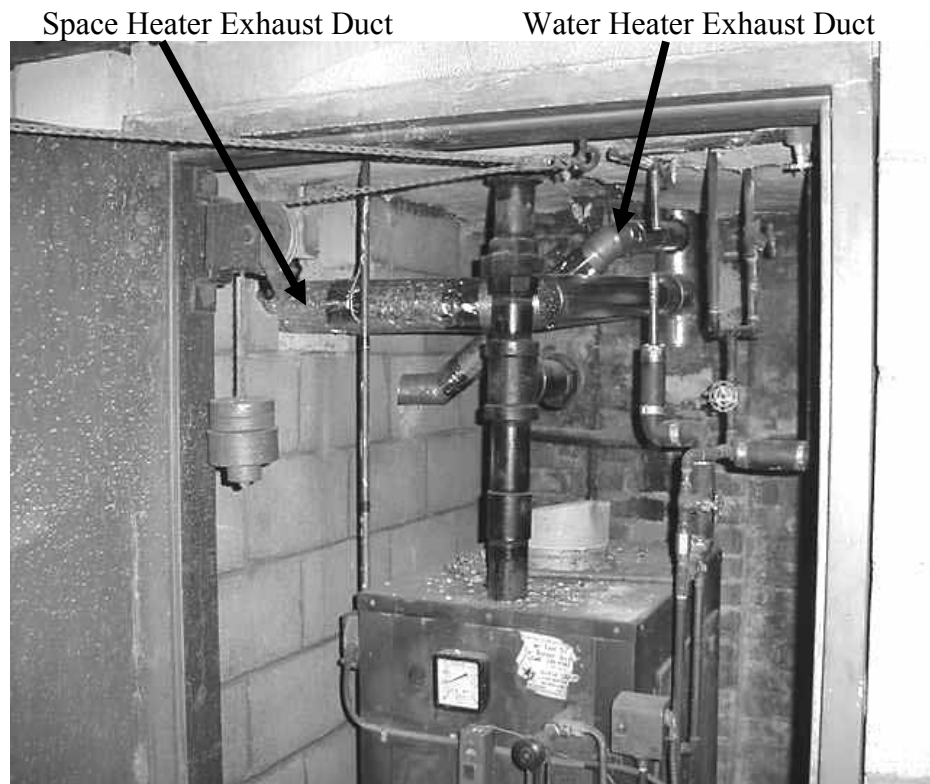
Picture 7

The water heater and space heater are vented into a chimney by roughly horizontal ductwork (see Picture 7). The duct to the chimney connected to the gas water heater is also

approximately 12 feet in length and has an estimated 360° in turns of duct. In addition, ductwork to the chimney connected to the space heater is approximately 12 feet in length and has an estimated 360° in turns of duct. In general, exhaust ducts should minimize the numbers of horizontal pipes and turns. Increasing length and turns in exhaust ductwork can decrease the efficiency of products of combustion to the chimney. If this occurs, products of combustion can pool in the ducts. Water vapor mixing with other products of combustion can create corrosive materials that can degrade the metal of the ductwork. The rapid increase in carbon dioxide indicates that the duct connecting the water heater to the chimney may have holes, which can release products of combustion into the furnace area. Products of combustion then may enter into occupied areas through spaces beneath the basement door (see Picture 8) as well as other holes that lead to occupied spaces. Operating equipment that draws air from the basement (e.g. the AHU and restroom vents) may enhance the draw of combustion products into occupied areas of the building.

Exhaust Vent Ductwork for Water Heater and Space Heater, Note Number of Angles in Ducts

- 3) To overcome the length and bends (turns) in the water heater and space heater vents, a power fan on each duct should be installed in the ductwork/chimney to facilitate removal of pollutants to the outdoors.

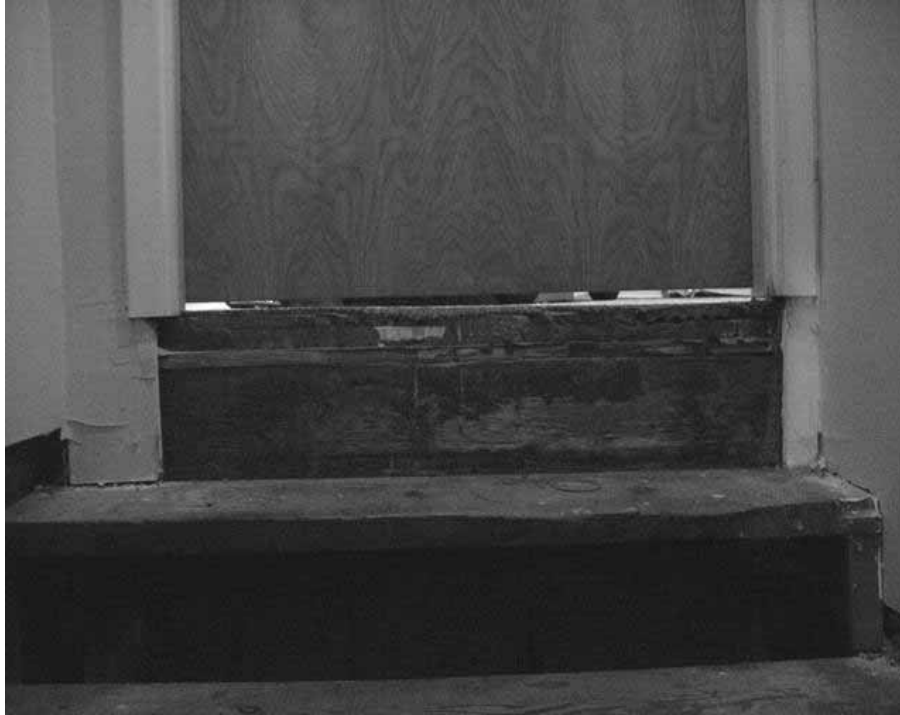
Picture 8

Space beneath Basement Door to Occupied Space

- i) Installing weather-stripping along the doorframe of the basement access door.
 - ii) Installing a door sweep at the bottom of the door of the basement access door.
